# Report on a Visit to the Trails of Greenberry Park

Rick Thom

September 9, 2021

On September 8, I walked the trails of Greenberry Park to provide some impressions of their condition and recommendations for improvement. I did this for the Jefferson City Trail Users Group. No visitors were present anywhere in the park on that day, which surprised me since it was Labor Day. I found that the trail makes a loop, starting to the right of the fire ring south of the parking area and ending just behind the maintenance shed by the picnic pavilion north of the parking lot. This is a small park and the entire trail and the side spurs probably total less than one quarter mile. However, it has great potential for wildlife and wildflower viewing, has some impressive, large trees, and it leads to an overlook of the Moreau River.

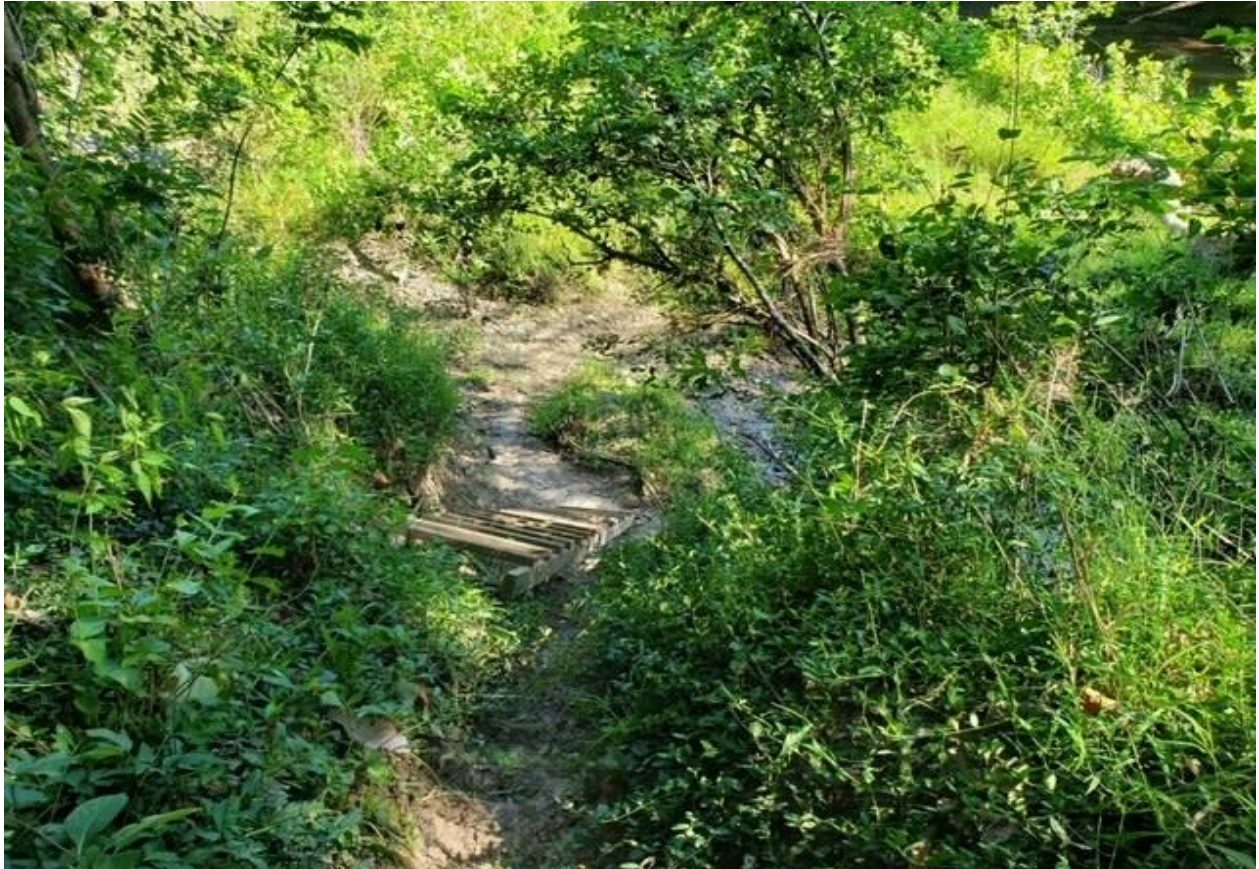
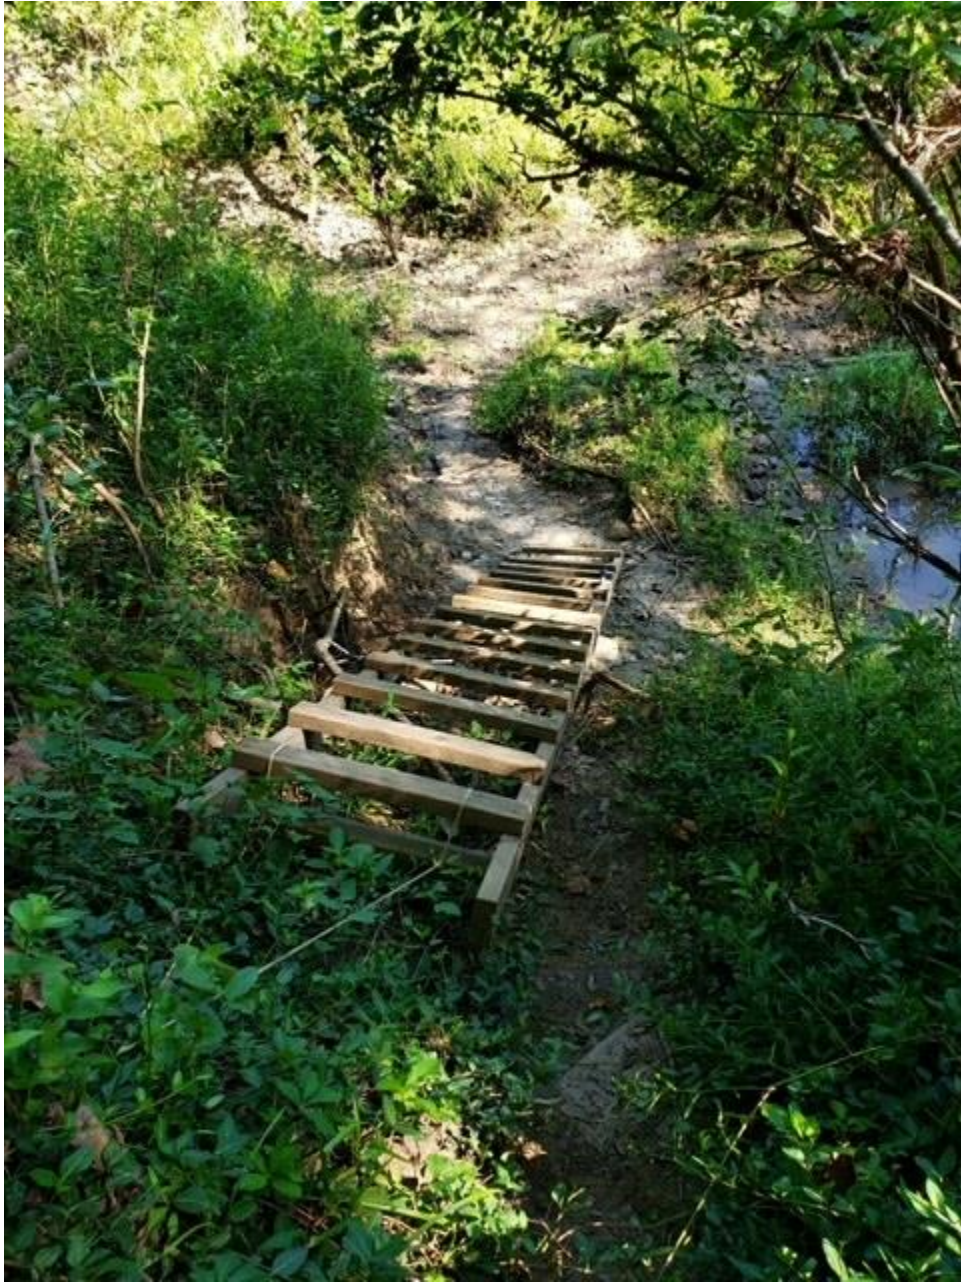
A short spur trail leads from the loop trail to the bank of the river. (A dead, 12 inch diameter ash tree between the trail and the river poses a hazard and should be removed). The trail ends at a steep earthen bank about 10-12 feet deep. To access the riverside, someone has built a ladder out of 2X4s that has fifteen steps and is about sixteen feet long. It is attached to the bank by a rope tied to a tree root that protrudes from the bank. The second to the last step is missing. The ladder seems fairly new and works well, but it would present a problem for people that are unable to use a ladder, and it is somewhat awkward to get onto the ladder from the trail. There needs to be a better access to the river, but this will be an expensive problem since whatever is built will be washed away by flash floods. I don't think steps and decking would be practical for this reason. The ladder probably worked because during a flood it can either be pulled up out of the floodplain or allowed to drift with the water and repositioned after the flood subsided. It was the cheap and

practical solution when this was a girl scout camp. As a city park, this looks like a liability problem, even though I was glad to be able to get down to the water.

#1--Ladder to Moreau River

#2--Ladder to Moreau River

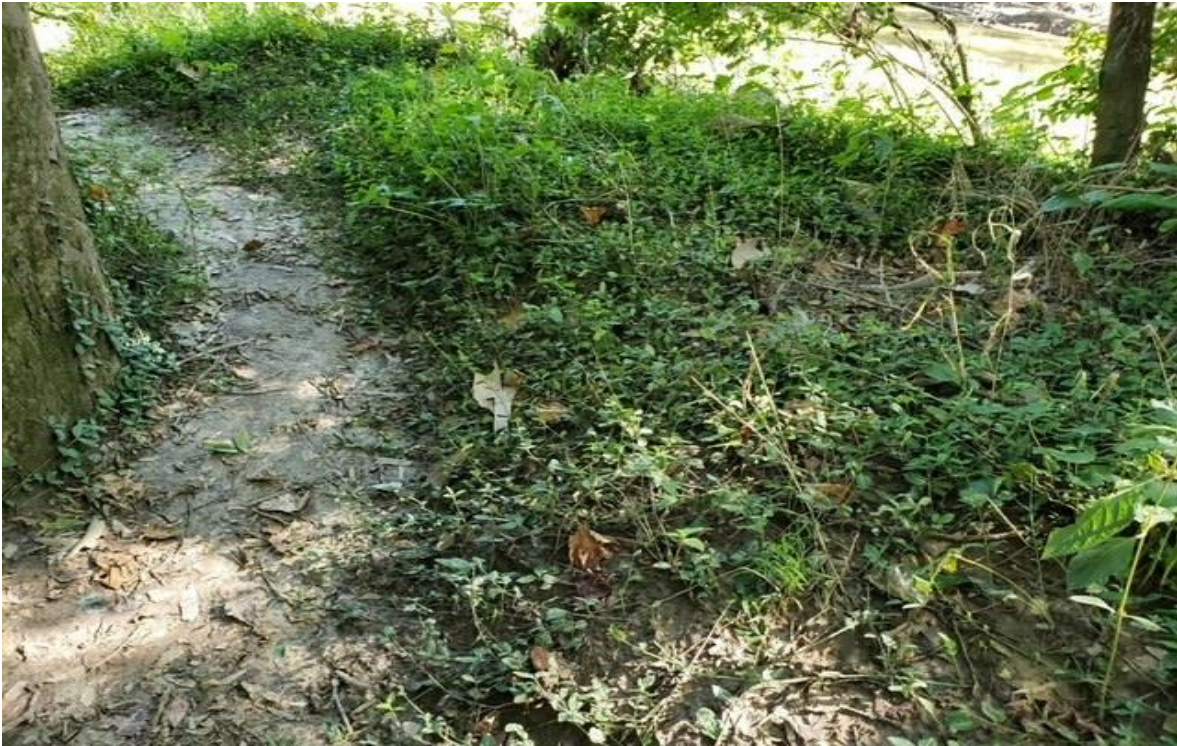
By far the biggest problem with this trail, and with the entire area, is that is covered with invasive exotic species that area choking out the ground flora and replacing the natural reproduction of the trees with shade-tolerant, exotic plants. The worst of these are shrub honeysuckle and wintercreeper. There is also Japanese honeysuckle. These are the three that I noticed, and they are everywhere. They have been there a long time. Much of the honeysuckle is 8-10 feet tall with 2-3-inch stems. Wintercreeper covers much of the ground and climbs many of the large trees. If these exotics can be removed, many native wildflowers would probably reappear, and others could be reintroduced. This could be a beautiful place to view spring woodland wildflowers from a short, accessible trail. It would also be a wonderful spring birding area with its large trees, rich understory, and proximity to water. It would be full of warblers during migration, and probably is now even with the invasive species understory.

#3--Sandy Trail with Invasive Plants

Maybe removing the invasive woody plants would be possible given the small size of the area and the short length of the trail. It would take commitment and determination, and some resources to accomplish this.

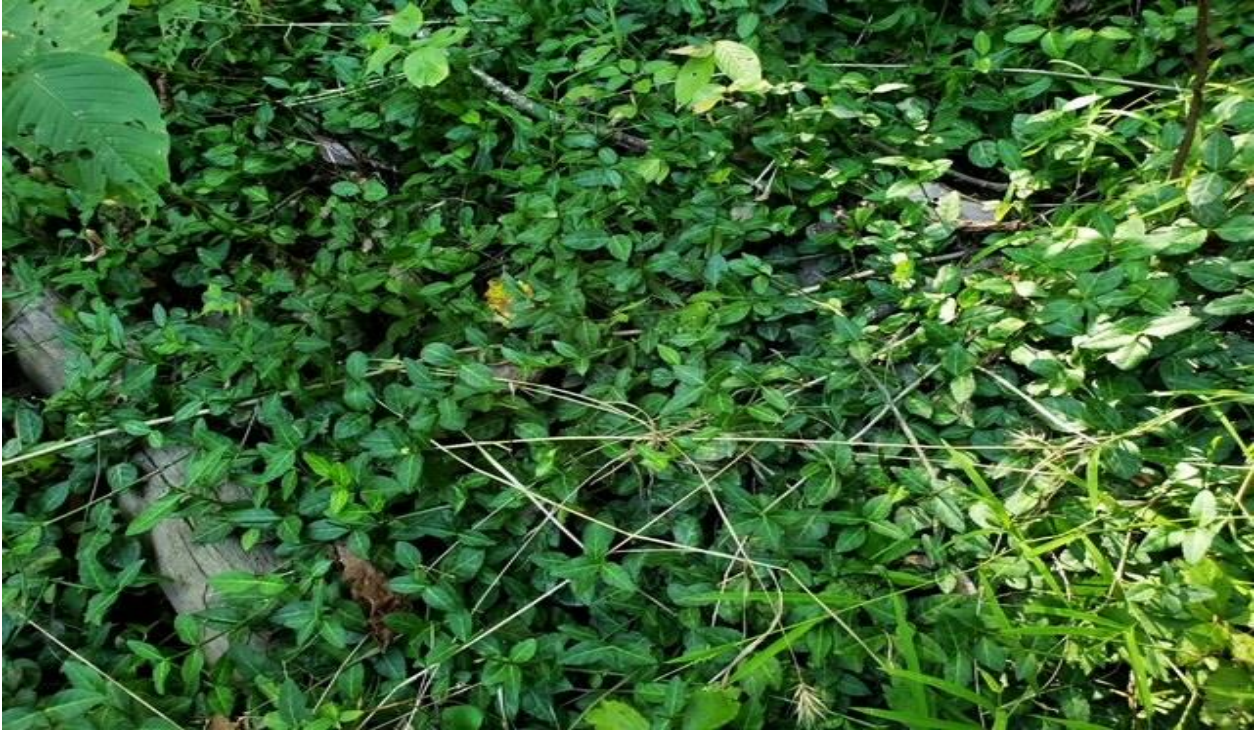
#5-- Wintercreeper

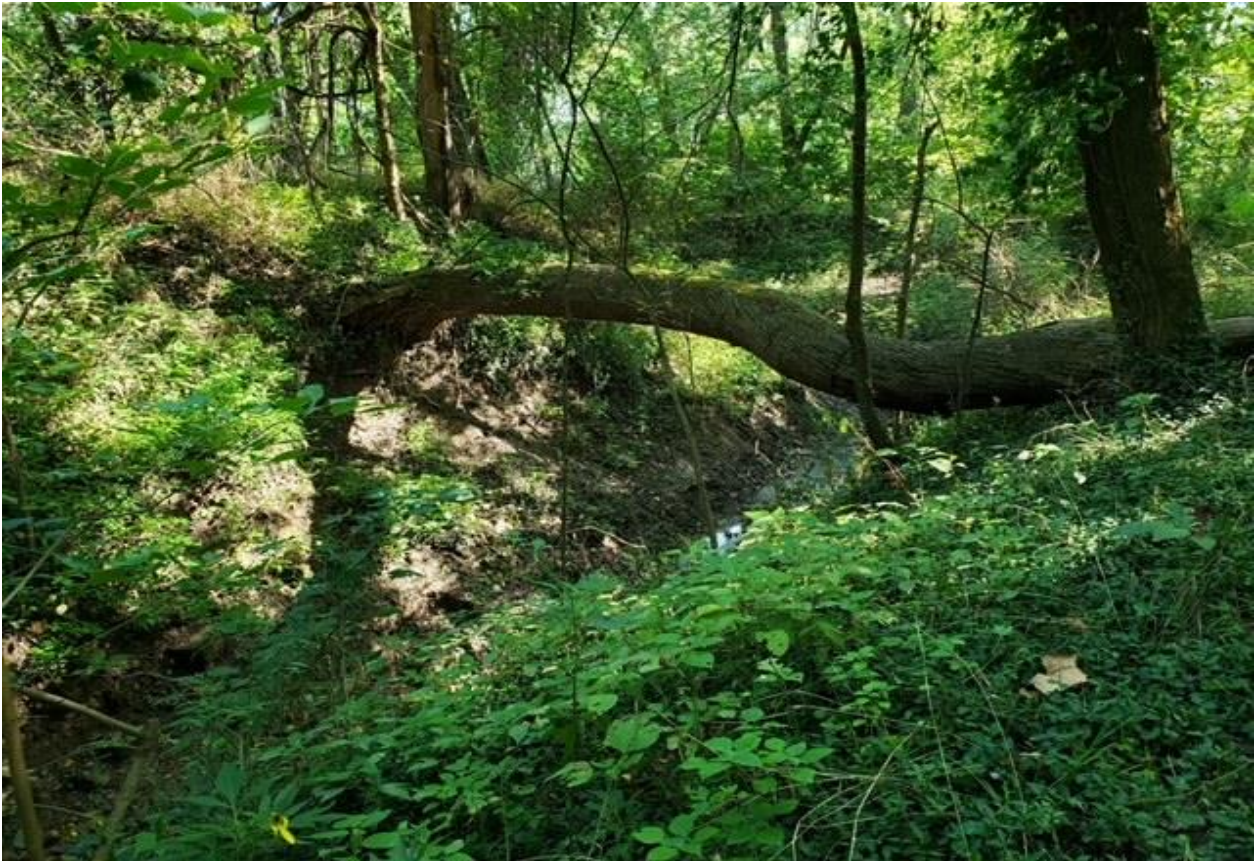
The treadway was in better shape than I expected. It was generally clear and easy to follow. It is steep in places but not badly eroded or entrenched. There was one large tree over the trail that needs to be cleared from the treadway. The sides of the trail could use some trimming. There is one deep draw that the trail spans with a bridge with a hand railing. The bridge seems well designed but is old and will soon need to be reinforced or replaced. For now, it works.

#6-- Tree over Gully

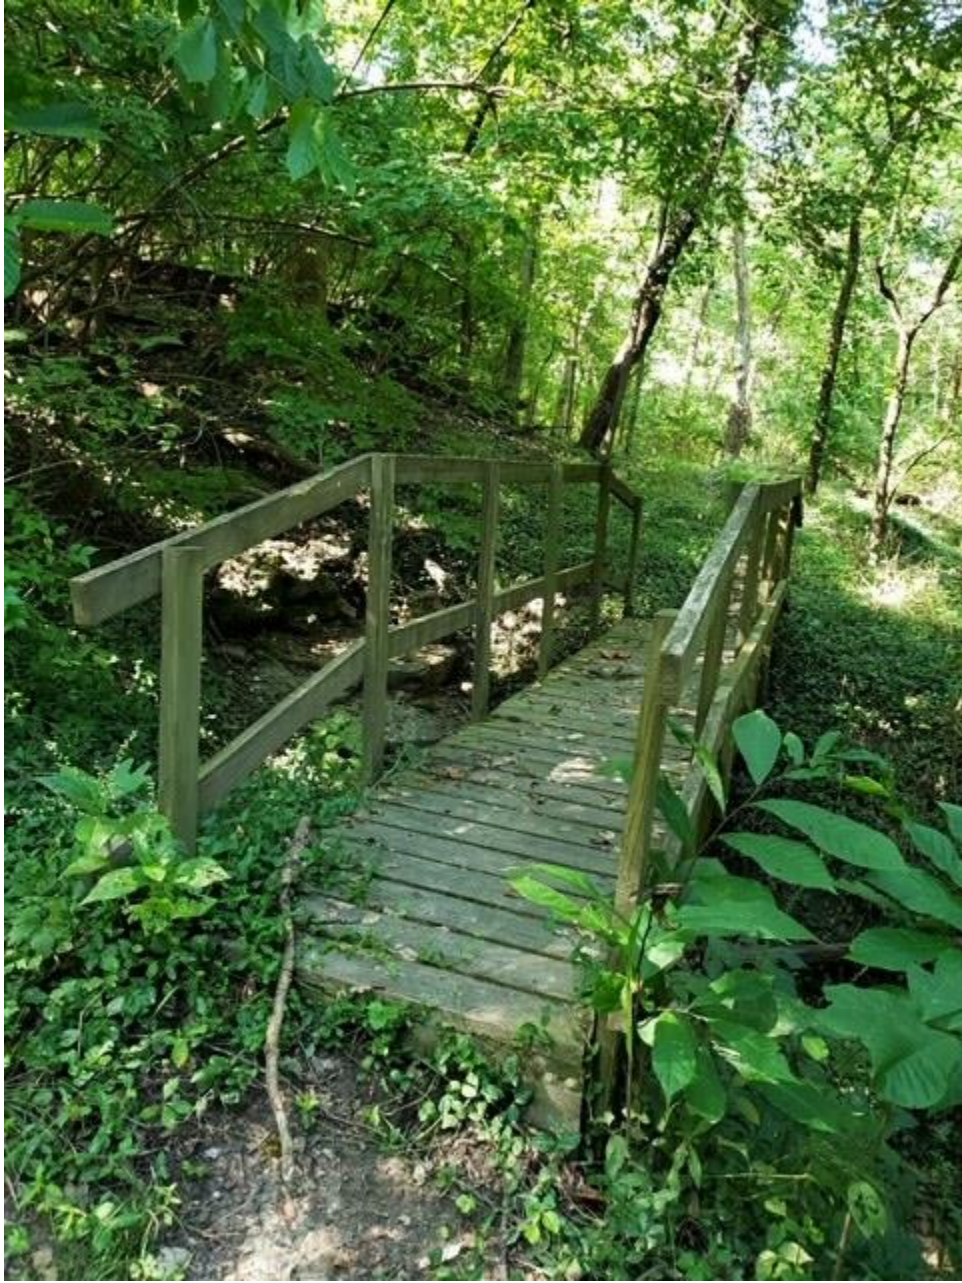
#9--Bridge

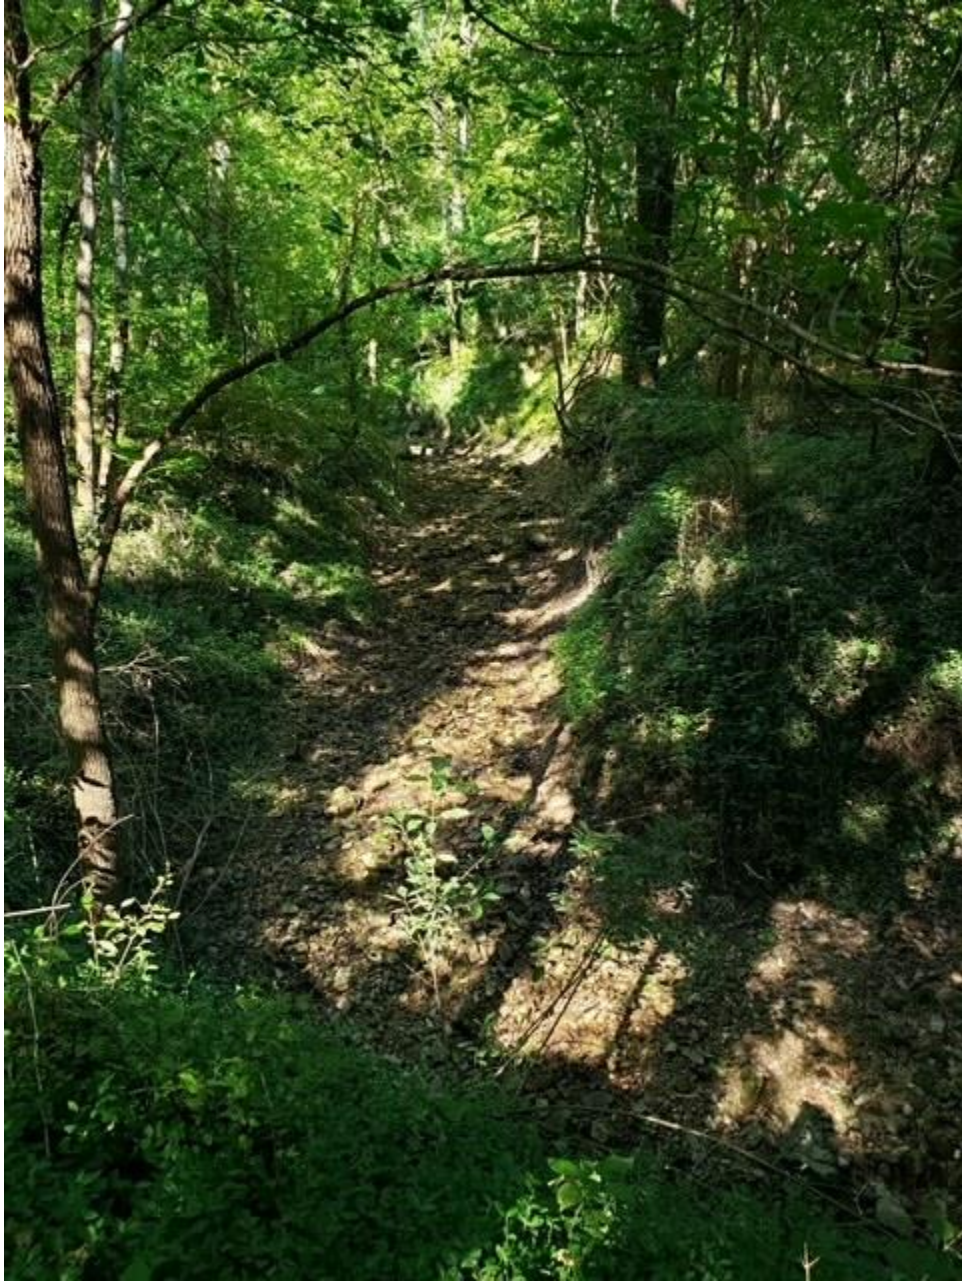
#10—Trail Tread
